INSPECTION REPORT

Permittee: *National Coal, LLC*

Permit No: *3249*

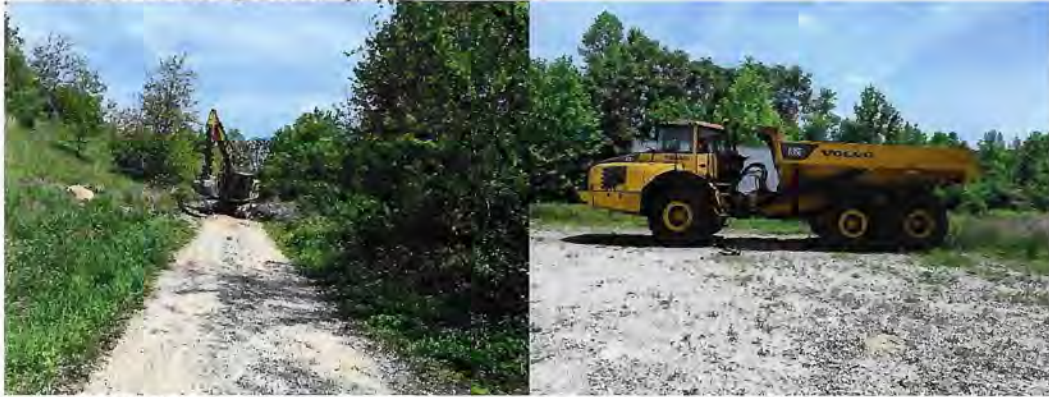
- Haul road #1, the haul road from the county road up to the contour, is a permanent road.
 - Multiple slides are affecting this road. See enforcement actions below. Equipment has been brought on-site to address this violation.
- Haul road #2 connects at the contour elevation and continues west to the end of the permit.
- Haul road #4 runs from the gap at the head of the river watershed to the end of the mining in the creek watershed and is well maintained.
- Several internal roads were constructed during mining and those roads have been scarified and vegetated.

Above left: Work being done on a slide on Haul Road #1 (photo 4/29/2019). At right: A wiggletail dump truck that was recently brought on-site (photo 5/8/2019).

- The abatement date is: Immediately.
- NOV N19-090-535-001
 - Violation 1 of 1 was issued for failure to maintain the haul road.
 - The corrective action is: Stabilize the areas which are showing signs of movement and return the road to its design criteria. Seed and mulch disturbed areas including road berms.
